**SAS Superstructure**

Daily Diary Report by Bid Item

Contract No.: 04-0120F4

Diary #: 006 Const Calendar Day: 157 Date: 12-Feb-2010 Friday
Inspector Name: Wilcox, Jason Title: Transportation Engineer

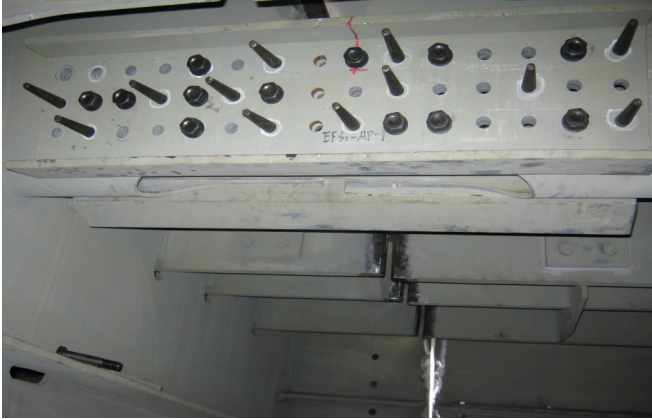
Splice 1 Initial U-Rib Bolting South side

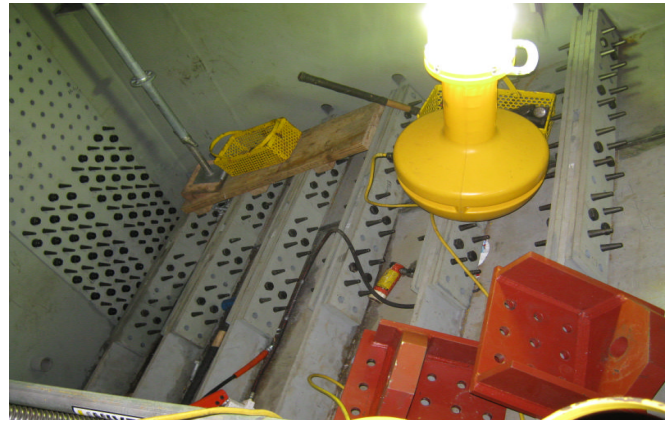
Splice 1 Initial Side Plate Bolting South side
